Detecting Cracks in a Rail Axle Center Using Eddy Current Testing

A customer needed a conventional eddy current solution to detect cracks in two areas of a rail axle center: the counter and the center bores. The goal was to create a solution to minimize operator intervention with both equipment and instrument settings.

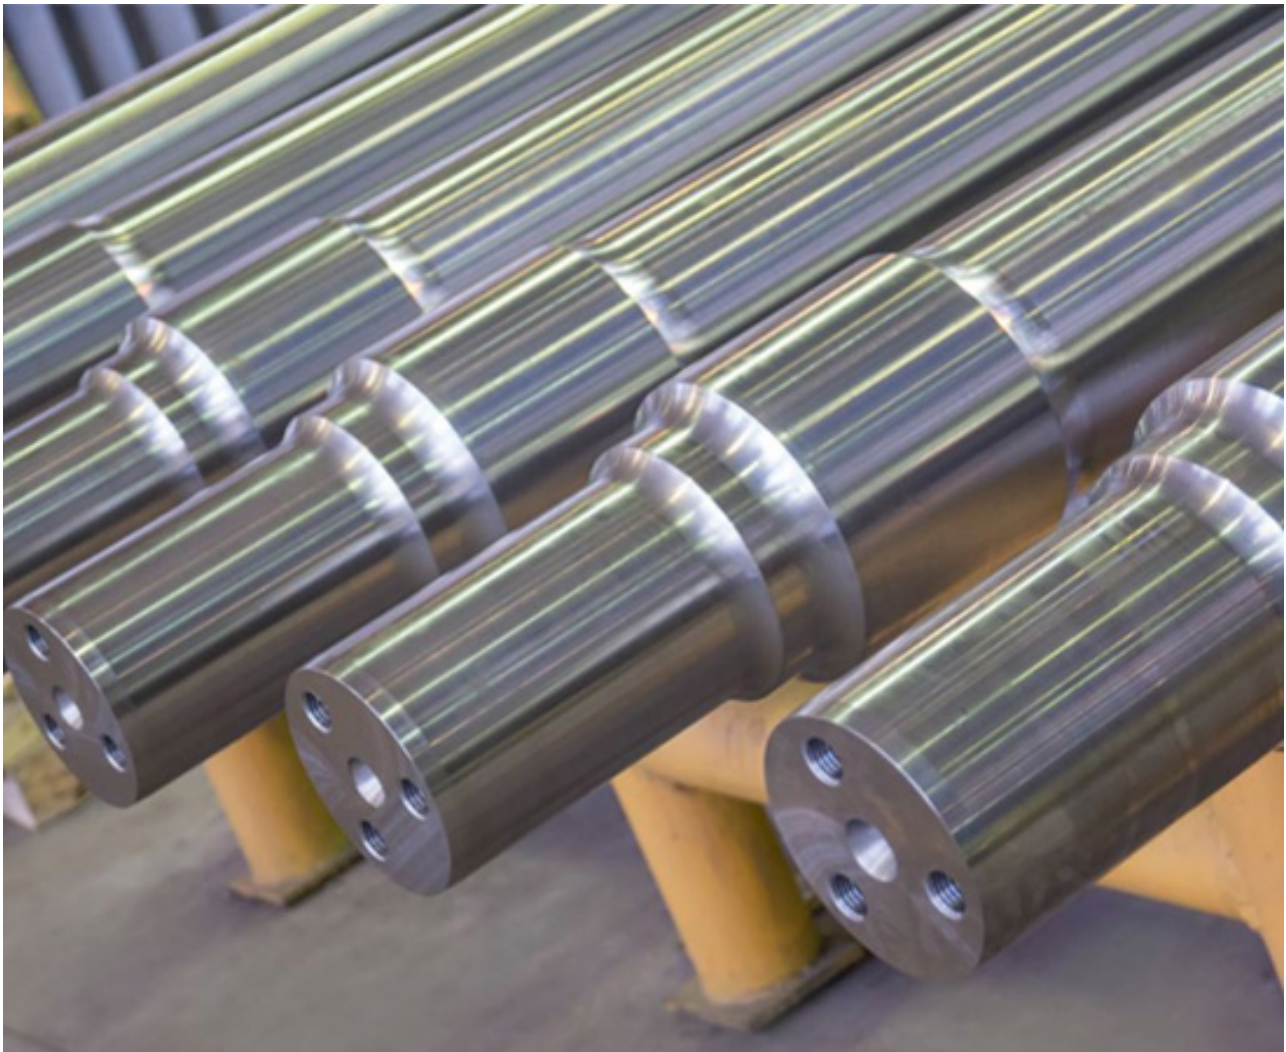
Axles

The axle shafts are forged and then machined down to meet internal specifications. The forging process can generate surface and internal defects, such as hairline subsurface cracks, inclusions, and pitting. When machined, internal deformities can increase in size and break the surface. These defects can lead to part failures.

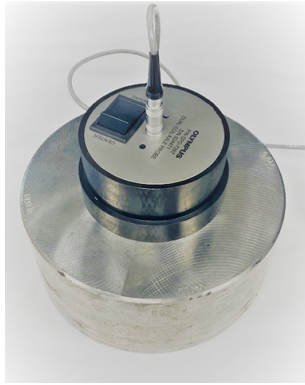
- NORTEC™ 600 eddy current flaw detector
- SPO-7397 custom dual coil axle center probe—Q6100015:
 - The probe contains one bridge differential coil to test the length of the tapered section and one small bridge differential coil to test the bottom bore of the axle center

Probe setup to inspect defects in a rail axle center

The test setup involved placing the probe in the axle center, using the switch to set the area of inspection (taper or center), nulling the coils, and rotating over the electrical discharge machined (EDM) notches provided by the customer.

To change areas of interest, the operator must simply switch the selector to change coils, input the appropriate test settings, and null the instrument.

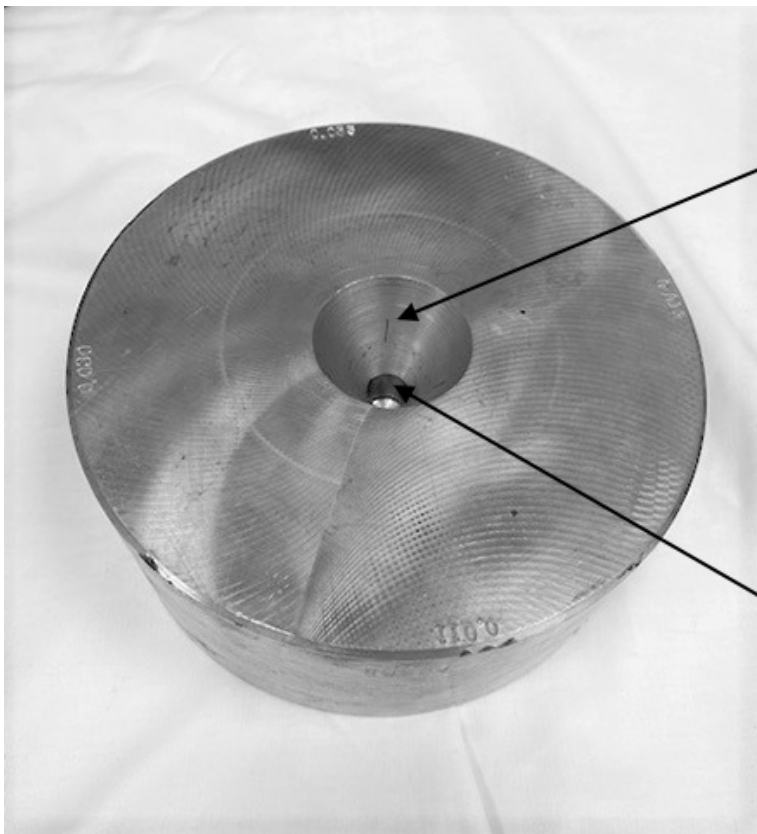
Tapered (countersink) axial flaw
(0.889 mm or .035 in. deep)

Center bore axial flaw
(0.381 mm or .015 in. deep)

The following images were taken from tests using the SPO-7397 probe on a supplied reference standard in both locations with the NORTEC 600 flaw detector.

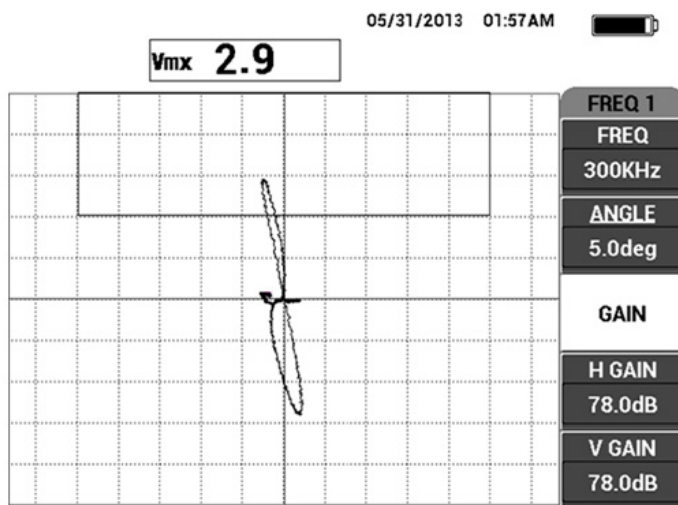
Test signal on a notch (0.889 mm or .035 in. deep) in the tapered section of the center

Both tests can be conducted at 300 kHz with minimal changes in settings. Gain adjustment and angle adjustment can be used to improve results.

As seen in the instrument screenshots, notches on the customer-supplied test/reference standard were detected with a favorable signal-to-noise ratio. The eddy current solution reduces the changeover time between area of inspection setups. This successful application may lead to further probe designs for different axle geometries and can also be implemented into an automated solution.

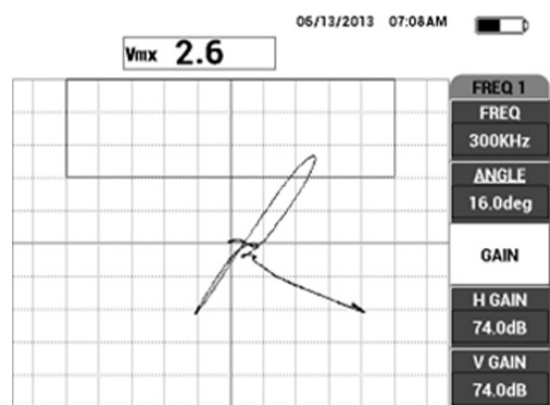
Test signal on a notch (0.381 mm or .015 in. deep) in the center bore
